# A model for the reuse of disused tanneries

## A case-study for the definition of the intervention criteria

**Abstract**—*The regeneration of abandoned buildings and industrial areas is extremely topical due to its significant effects on socio-economic issues, urban planning and environmental protection. This contribution presents a model for the reuse of abandoned tanneries. The model considers issues regarding the buildings and their urban environment based on an integrated multidisciplinary approach. In particular, the study is divided into the following phases: compatibility between the choices and urban policies; analysis of the potential conversion of the tannery; assessment of compliance with technical standards (structural safety, fire safety, elimination of architectural barriers, energy efficiency); definition of intervention criteria. The tannery district of the City of Solofra in the Campania region of Italy was chosen to calculate the parameters of the model.*

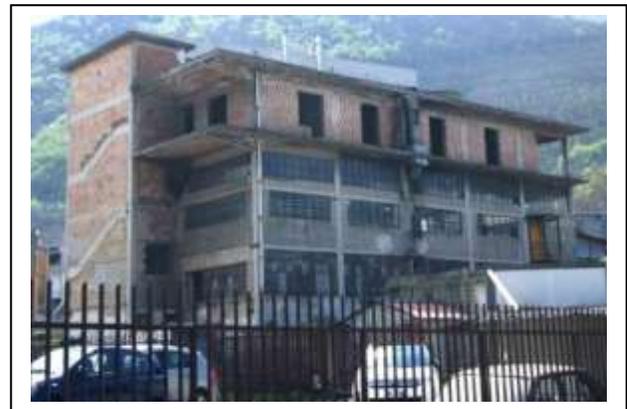
Figure 6. The abandoned tannery

Built in 1979, the tannery has a reinforced concrete framework and trapezoidal layout; the longer side measures 26.50 m, the shorter side 14.00 m. The building has three floors; the roof stands 13.60 m above ground (fig. 6).

The ground floor has three entrances and is divided into two large spaces with 5 m ceilings; yellow tuff blocks are used as infill in the outer walls; the simple glass and iron door and window frames stretch from one pilaster to another around the whole building.

A single staircase on the short side of the building leads to the first floor; the external first floor walls are made of hollow concrete blocks; the height inside is 5.00 m; there are two rows of ribbon windows at different levels from the floor, one at a height of 1.20 m above ground and another at 1.80 m. These windows run all around the building.

The second floor was never finished: there are no window or door frames; the external walls with a double hollow brick lining and air cavity are missing in many parts of the building; the ceiling is 3.00 metres high and the roof is flat.

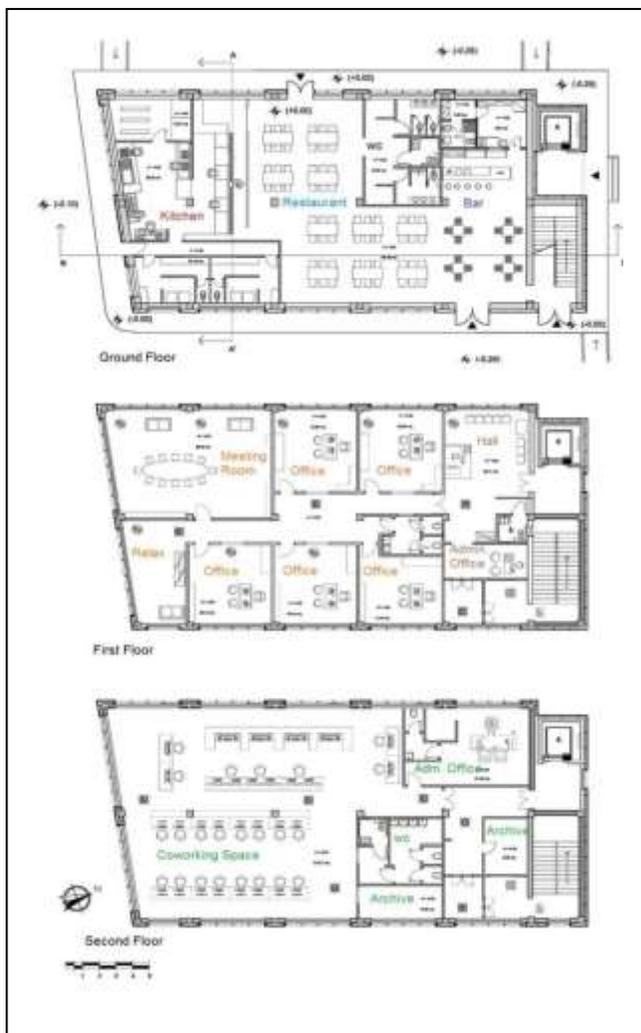
Figure 7. Possible reuse of the former tannery: plan with new uses.

As part of the general requalification project illustrated earlier, and after critical assessment of the indicators of transformability described in paragraph III), the former tannery proved to be a good candidate for conversion to tertiary activities. In particular, it could be used as a restaurant on the ground floor and offices on the other floors (fig. 7). Before the building can be used for these purposes checks must be run to see whether it complies with the main technical regulations in force in Italy.[15, 16, 17, 18, 19, 20, 21]
