Damages in adjacent structures due to foundation excavation

II. The Case Study

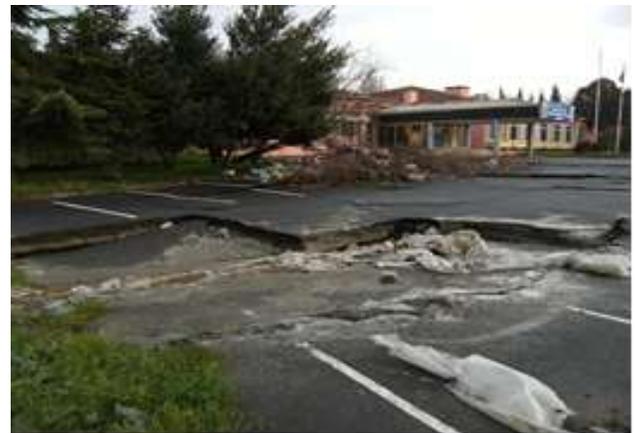
Technical examinations are carried out in the common areas and blocks A/B of Hospital structure (Building-1), one of the damaged structures. In the observations and investigations in Block A, (i) Soil movements and collapses are occurred in garden area, and the roads around the structure (Fig. 2), (ii) Tension cracks and separations are occurred in boundary walls in the direction of foundation excavation direction (Fig. 3), (iii) Especially in the south facade overlooking the deep excavation, it is observed that separations in RC members and connections including rotations as a result of torsional effects due to sliding and subsidence of the ground (Fig. 4). The left part of the building block A is heavily subjected to, damaged deviating from the plumb line, so its stability and carrying capacity. have completely run out. Structural damage is not determined in the basement floor on the right side of the main entrance. The members subjected to damage is not observed in pool area of the third unit which has partially basement floor. In the observational examination of building block B is 220 m of the distance from the excavation site, especially in the wet areas of without basement unit on the left side of the main entrance, 45 degree angled tension cracks are appeared on walls depending on ground subsidence. Accordingly, micro cracks are occurred in wall-beam connections [22].

Figure 2. The failures around Building-1

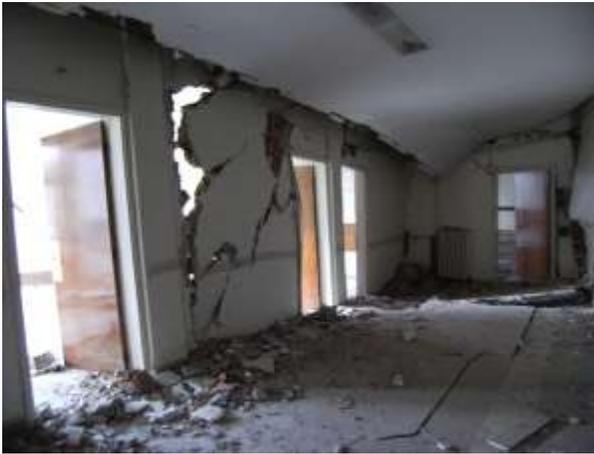
Figure 3. Damages in Building-1

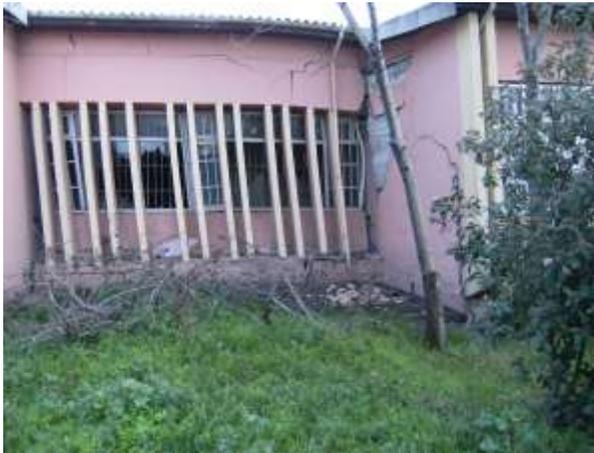
Figure 4. The damages in structural members of Building-1

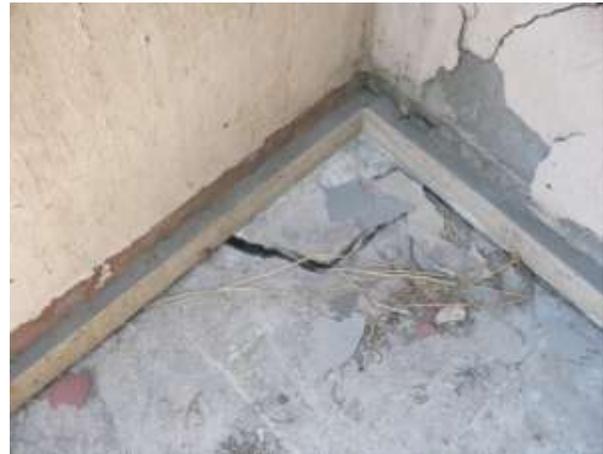
The damaged other structure, two-storey RC framed and Building-2, is separated with a dilatation and consists of adjacent two groups of two blocks. In observations in the structure, (i) Soil movements and collapses are occurred in garden area, and the roads around the structure, (ii) Tension cracks and separations are occurred in boundary walls in the direction of foundation excavation direction, (iii) In the group I including Blocks 1 and 2, it is observed that cracks in connections of RC members and infilled walls, and 45 degree angled tension cracks in column-beam connections, (iv) It is determined to deviate from the plumb line the Block 2 of building group I (Fig. 5-8) [22].

Figure 5. The damages in slab and walls

The structure, Blocks 1 and 2 in building group I, couldn't use and repair due to separates in dilatation joints, collapses in garden and the mentioned issues. Therefore, it is necessary to destroy and rebuild of the building.

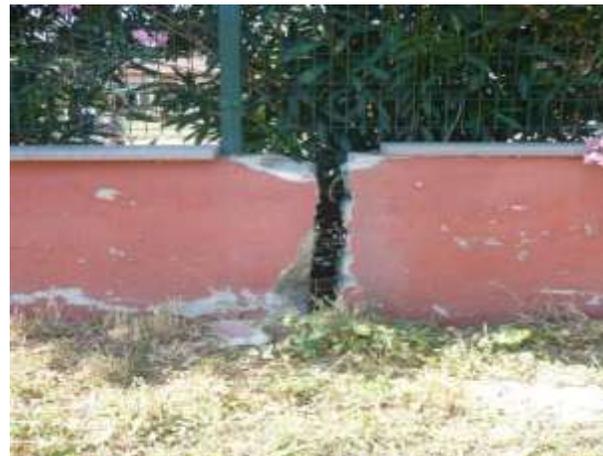
Figure 6. Separations in walls due to soil movements

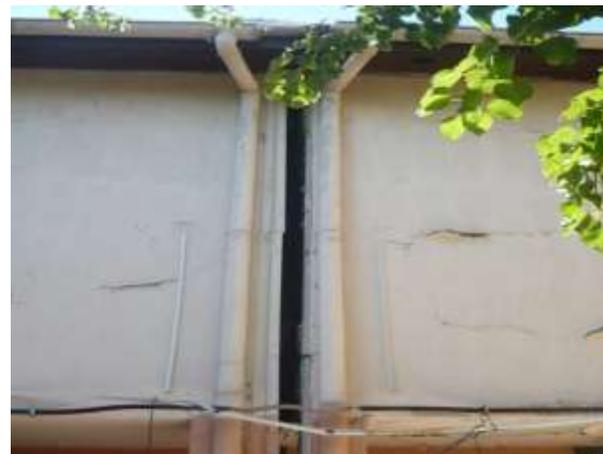
Figure 7. The separation in dilatation joints

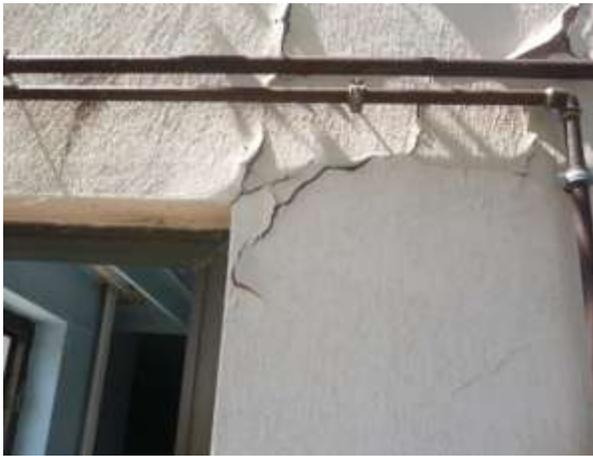
Figure 8. The cracks in column-beam connections

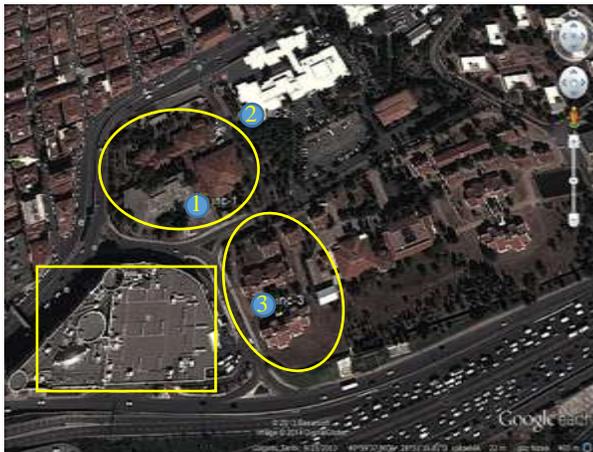
In selected three inclinometer wells around the examined area, measurements are performed on twelve different dates. Thus, it is determined that lateral movements, deformations in different depths of the ground. The selected well locations for inclinometer measurements are shown in Fig. 9.

Figure 9. The locations of inclinometer well
